Construction of Cape Peron ocean outlet Perth, Western Australia

B. G. COX, FICE, FIWES*

K. J. KELSALL, BE, FIEAust†

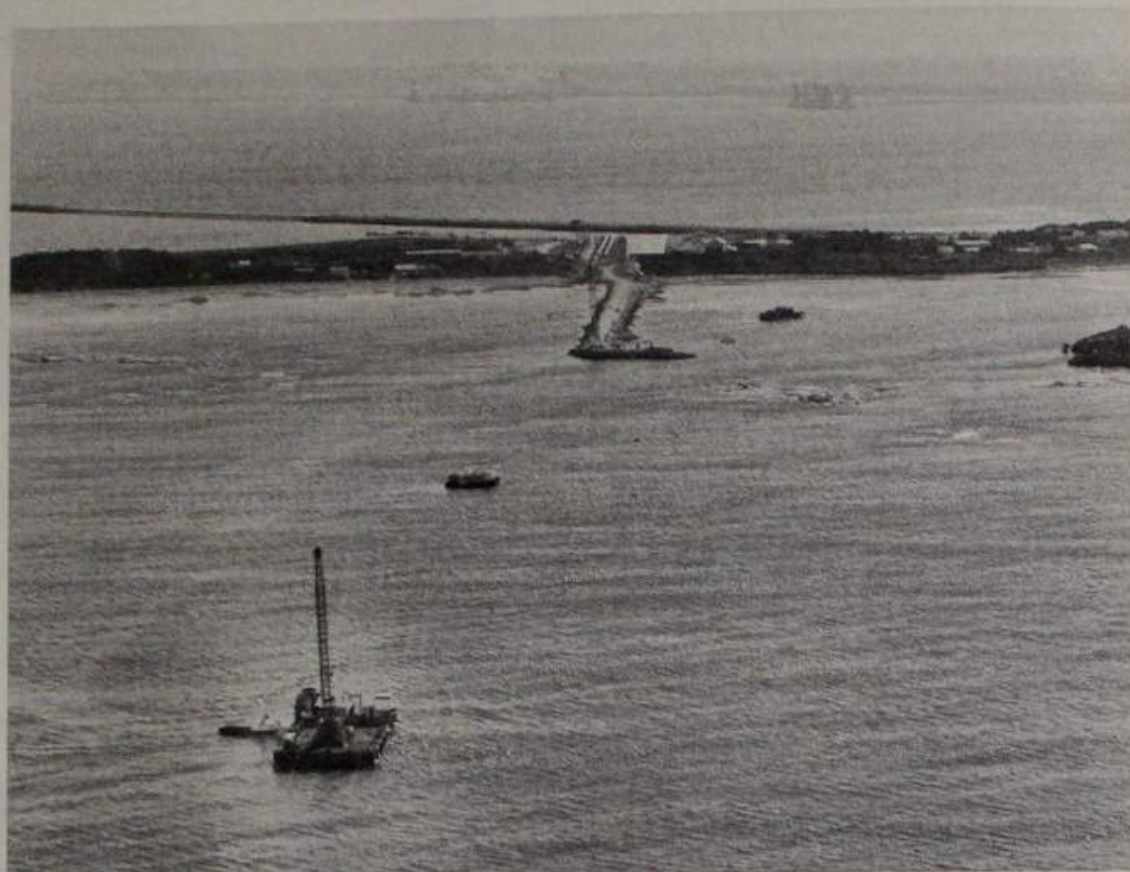
Fig. 1. Winch barge, block barge and Cape Peron pipeline launching area (Cockburn Sound and Kwinana in the background)

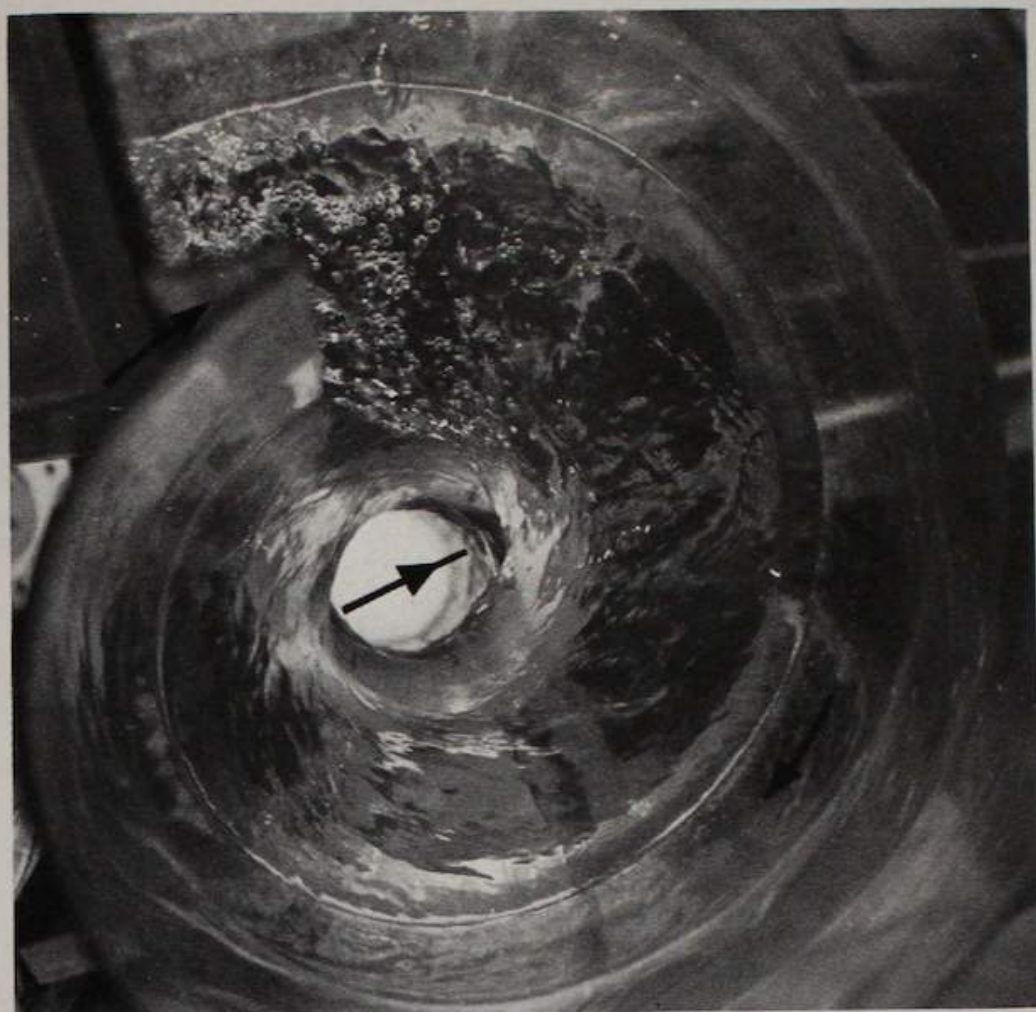
Fig. 7. Transition tower: one-tenth scale model test of vortex chamber for flow equivalent to 2000 l/s

chamber 12 m above sea level and flows spirally down a 1400 mm i.d. vertical drop pipe (Fig. 7). Hydraulic model tests were used to design for minimum air bubble travel into the offshore pipeline. A baffled deaeration chamber, 8 m long, extracts the air which is entrained in the vortex (Fig. 8). Ancillary equipment includes an odour removal unit and a foam suppression spray. For environmental acceptability the tower has been constructed with a fluted concrete surface, and white concrete columns support a spiral staircase (Fig. 9).

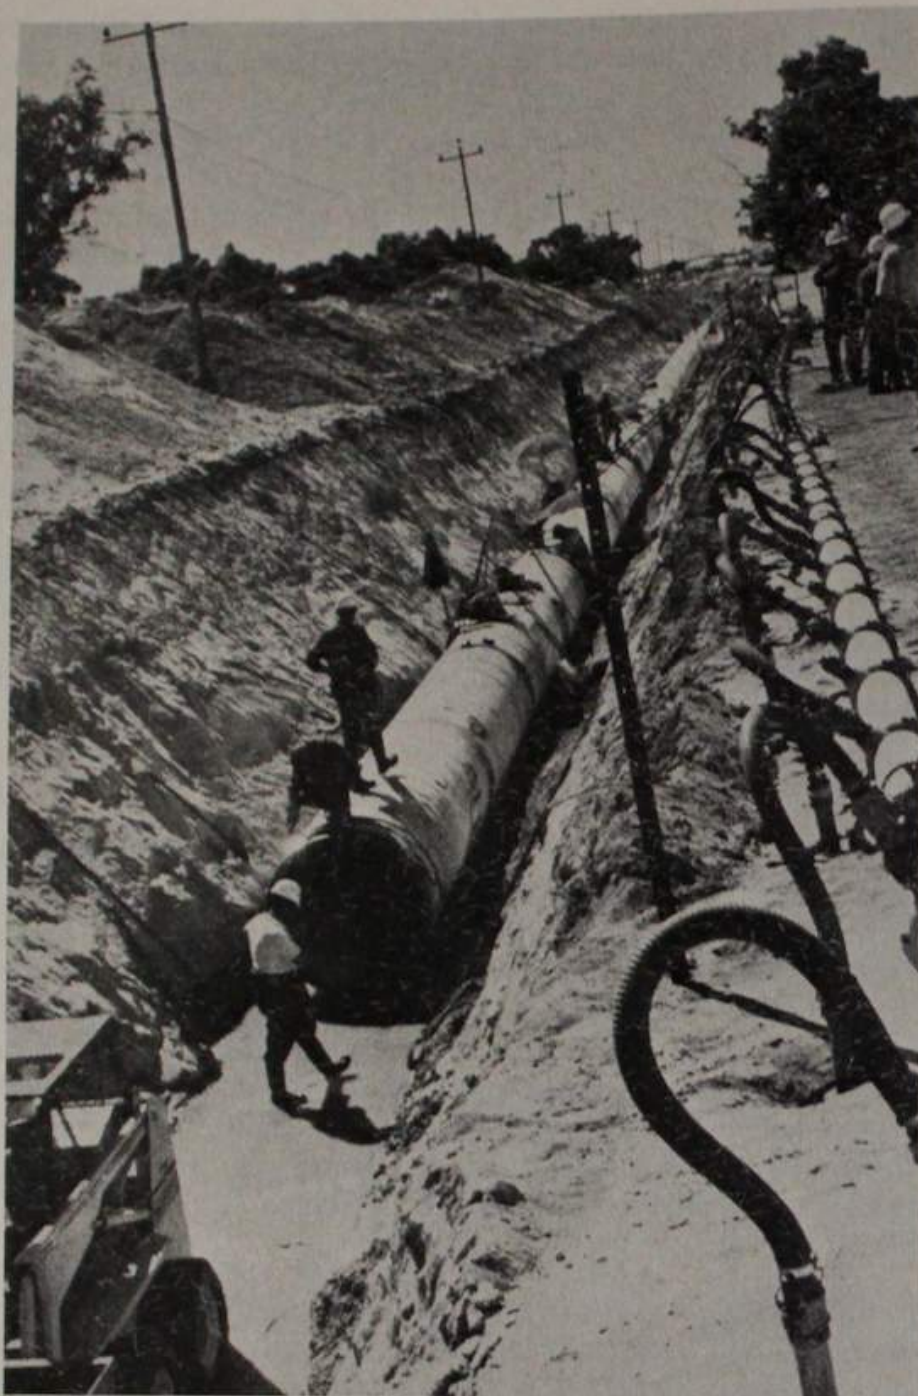
Fig. 11. Dewatering equipment on land pipeline with Parallel 3300 V power line for 5 km

27. Excavation was for 11 km in limestone and 12 km in sand. Dewatering was used extensively in sandy areas, with careful monitoring to limit drawdown and prevent saline intrusion of local wells. Laying of 23 km was completed in 14 months. The pipeline ran parallel to high-voltage power lines and towers (Fig. 11), and induced voltage mitigation measures taken for the protection of welders involved temporary bonding to the pipe of welding machines and metal footplates. Permanent induced voltage mitigation measures are being installed. Three impressed current cathodic protection stations have been provided with test points at 1 km intervals along the route and at foreign structure crossings.

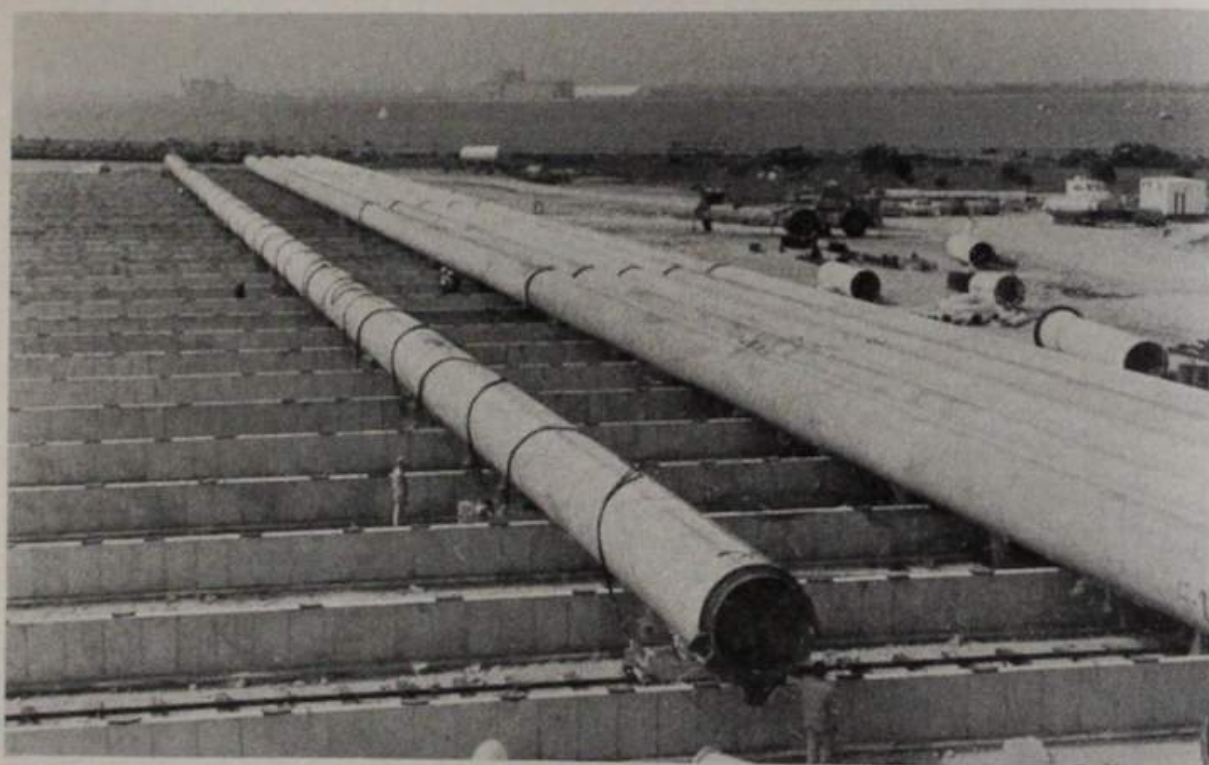
Fig. 15. Offshore pipeline: string transportation

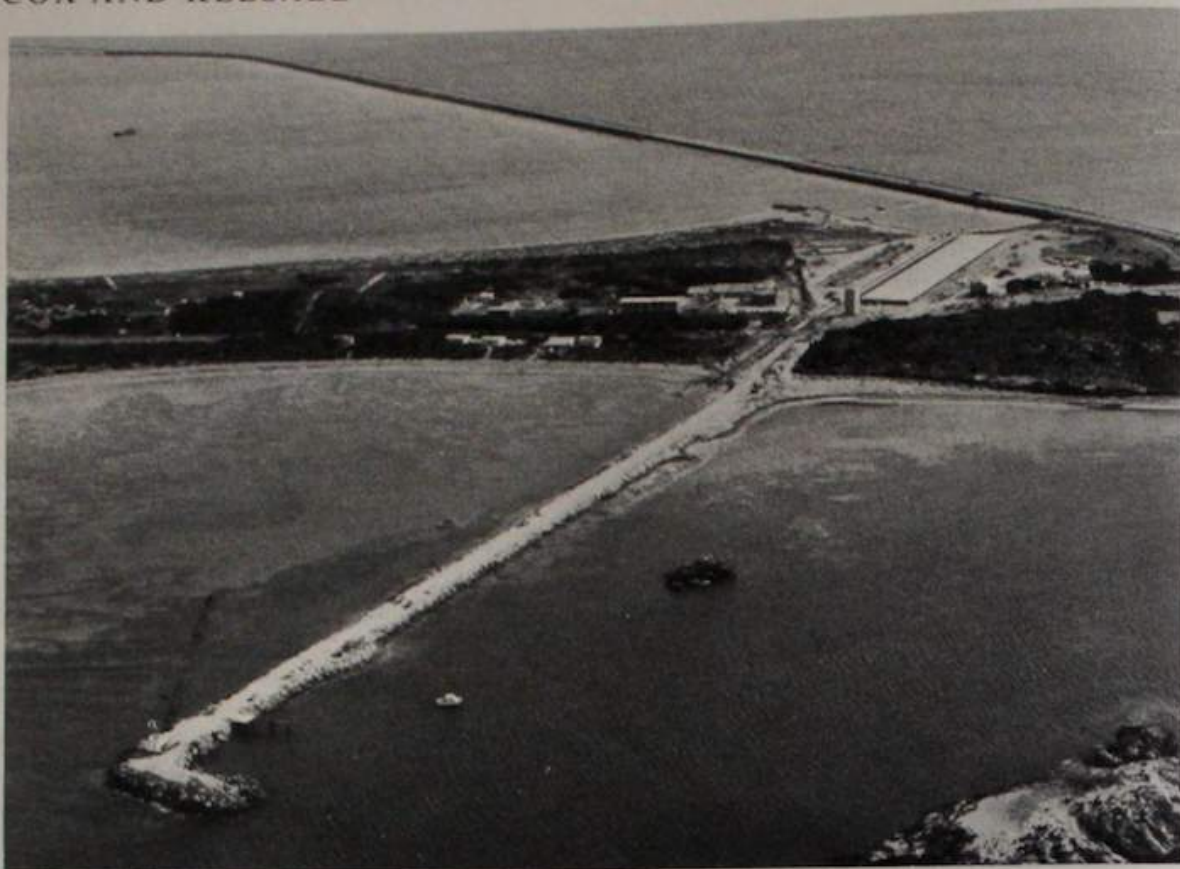
Fig. 17. Temporary groyne

35. In normal rough weather conditions the surf breaks heavily at a depth of 5 m about 600 m from the shore. A temporary limestone groyne (Fig. 17) was extended for 500 m to a depth of 3 m, and provided sheltered mooring and rock-loading facilities for tugs and barges. The 3 m deep trench alongside the groyne was mainly excavated by two large hydraulic back actors using the spoil to extend the groyne. For the next 2 km intermittent hard limestone outcrops required drilling and blasting. Two barge-mounted grab cranes excavated 80 000 m³ of sand and broken limestone in 8 months to form a profiled trench with a bottom width of 5 m. Hard rock was excavated to at least 500 mm below the pipe bottom. A 500 mm thick natural sand bedding was specified with a tolerance of plus 500 minus zero. Excavated material was transported in hopper barges to a spoil area. Alignment was maintained by a laser unit, and distance by radio link to a Wild distomat D120 on shore. Accuracy and economy in grab excavation to profile and line was effected by a Mesotech 952 bottom-scan profiling sounder (Fig. 18) used in conjunction with laser, distomat and a tide gauge. The trench in rock areas remained open after excavation but some sand trench excavation was 60% backfilled during winter storms.

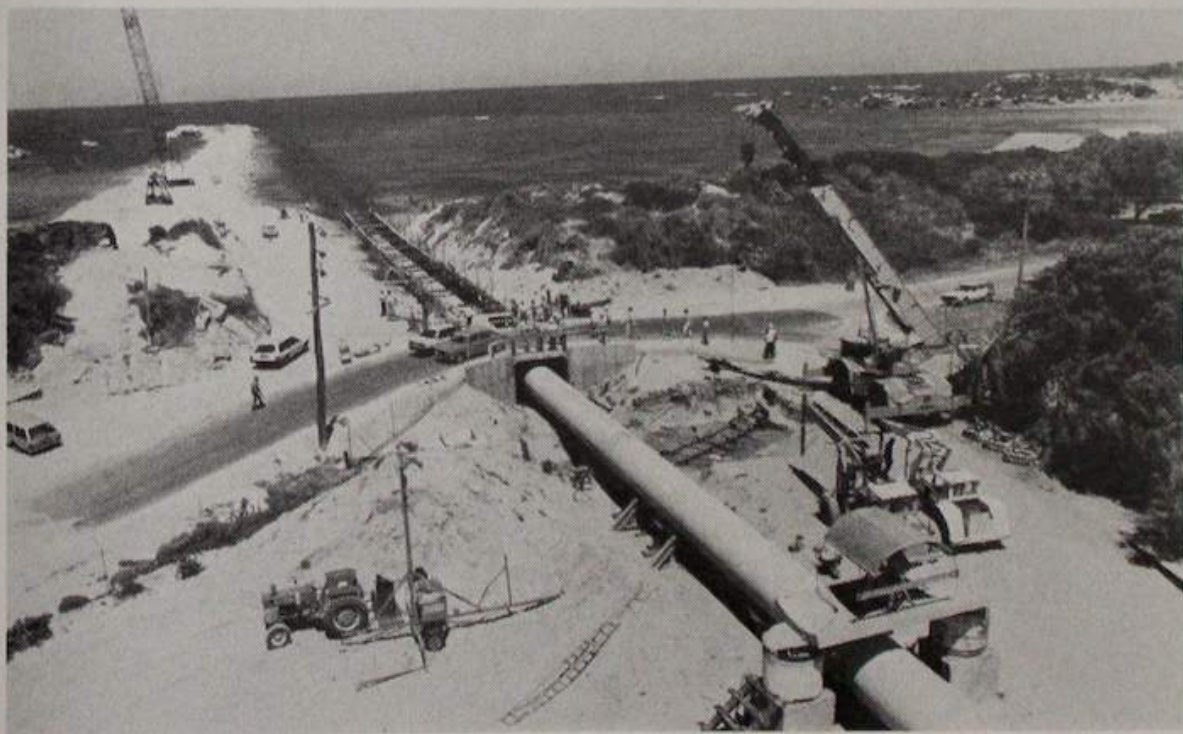
Fig. 19. Piled trench and road crossing

diffuser. Roller supports then carried the pipe on to the seabed. The entry into the water was arranged in a steel and timber piled trench 5 m wide. 250 × 250 H piles were driven at a spacing that allowed hardwood sleepers to be water jetted horizontally into the sand between the piles. A number of the rollers were suspended from this pile structure using adjustable steel rods to set the rollers to the correct level in the S-curved launchway profile. The 10 t roller ball bearing casings were set in bonded polyurethane tyres. During the operation the polyurethane disbonded on some rollers and subsequent distribution of load to others caused some bearings to collapse. Damaged rollers were successfully reinforced with greased hardwood railway sleepers. A temporary concrete culvert allowed the pipe to pass under the public road (Fig. 19).

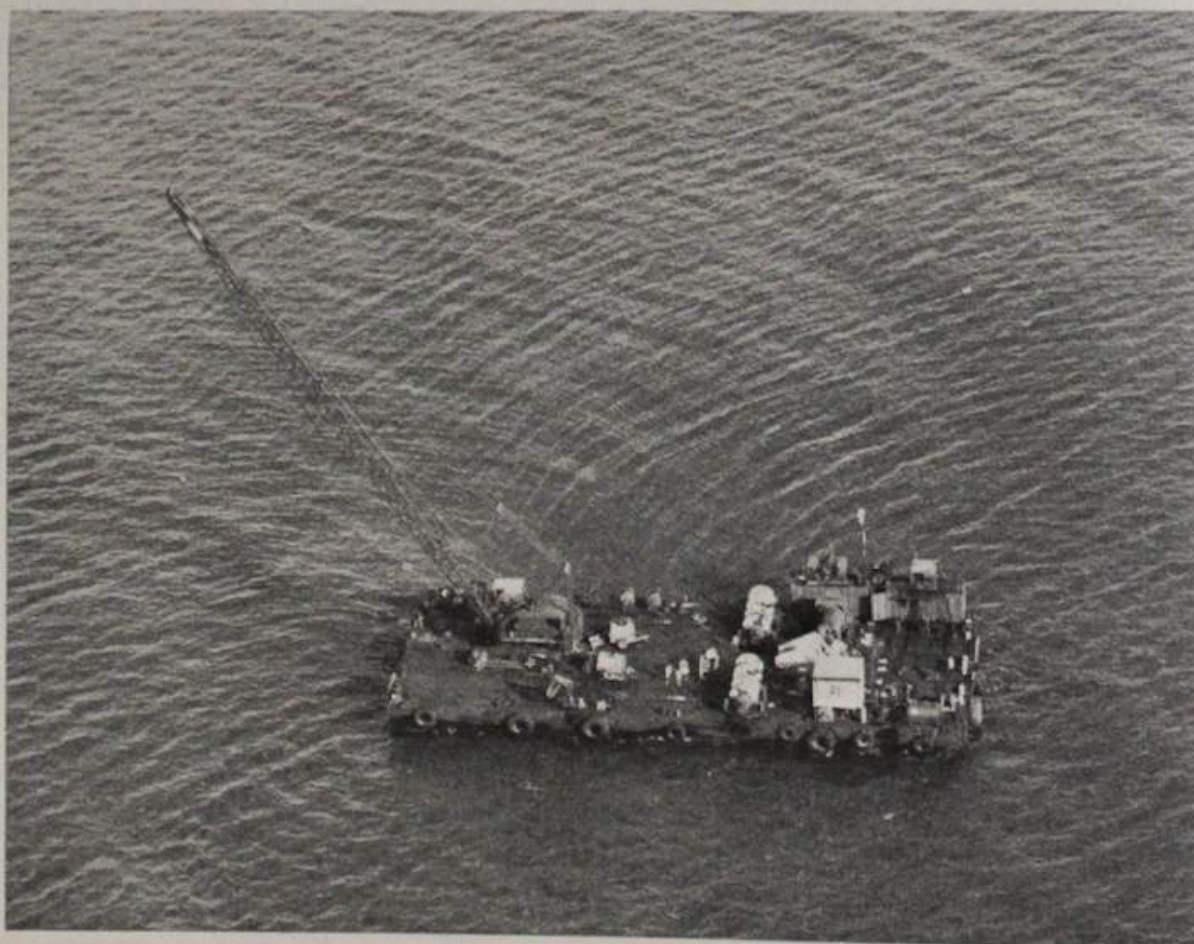
Fig. 21. Winch barge
